# Service Handbook

## Centralized Controller

**AE-C400A/EW-C50A**

**AE-C400E/EW-C50E**

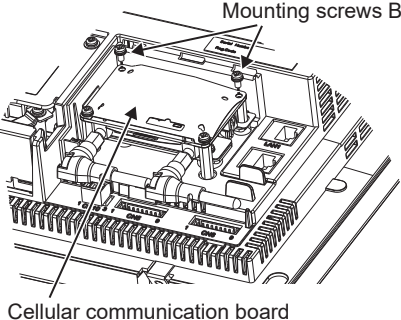
Step		
5	Remove the mounting screws B (two screws) from the board (cellular communication board) to which the communication antenna is connected.

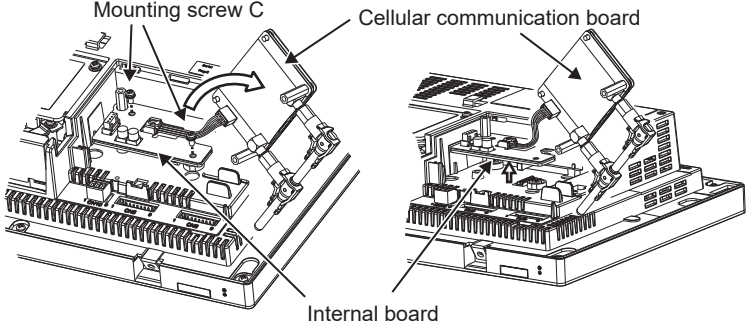
6	Turn the cellular communication board over as shown in the figure, remove the mounting screws C (two screws) from the internal board, and lift and remove the internal board. Go to step 8.

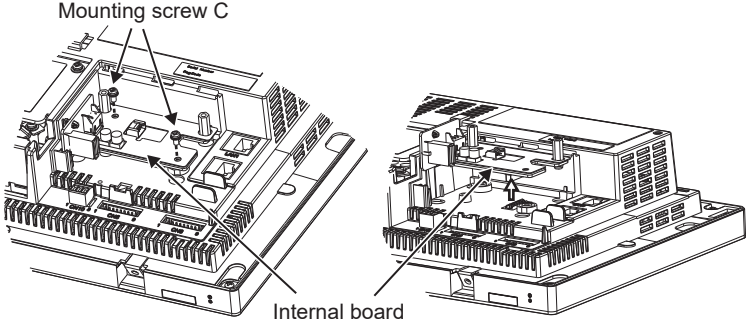
7	Remove the mounting screws C (two screws) from the internal board, and lift and remove the internal board.

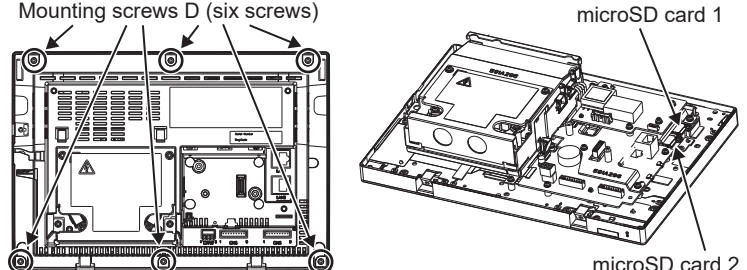
8	Remove the mounting screws D (six screws) from the rear panel, and remove the black cover. The SD card slots on the side of the controller will be visible.

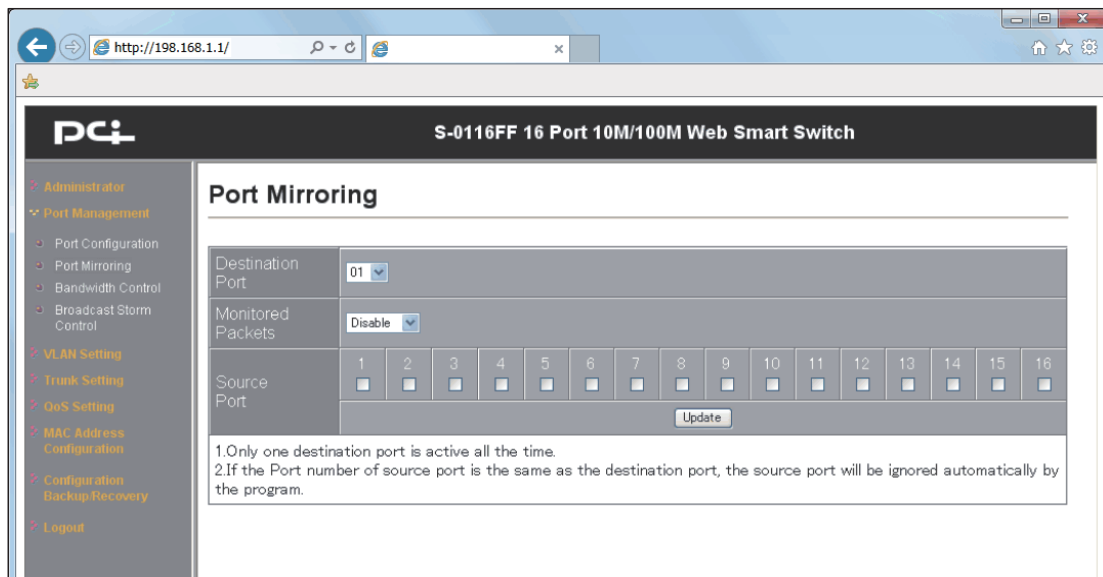
When using a switching hub that features port mirroring, configure the “Port Mirroring” setting. The setting example for Planex communication’s switching hub is shown below.

Configure the “Destination Port” setting for connecting the PC (Wireshark), and the “Source Port” setting for the monitoring target port. Multiple source ports can be selected.

If “Tx & Rx” is selected for “Monitored Packets”, both sending and receiving packets can be captured.
