# Service Handbook

## Centralized Controller

**AE-C400/EW-C50**

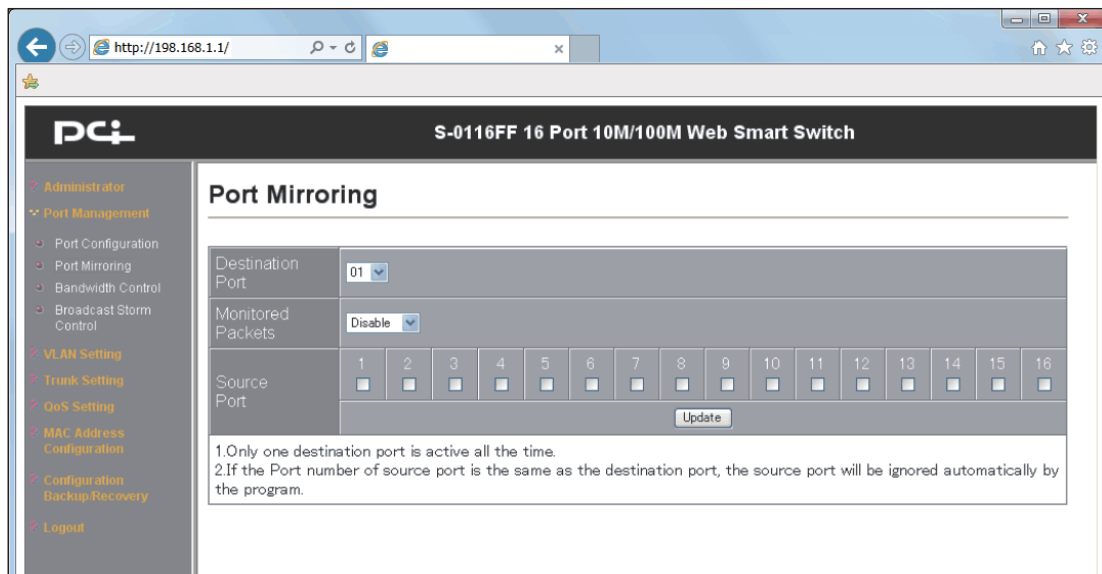
When using a switching hub that features port mirroring, configure the “Port Mirroring” setting. The setting example for Planex communication’s switching hub is shown below.

Configure the “Destination Port” setting for connecting the PC (Wireshark), and the “Source Port” setting for the monitoring target port. Multiple source ports can be selected.

If “Tx & Rx” is selected for “Monitored Packets”, both sending and receiving packets can be captured.
