# **Service Handbook**

## **Centralized Controller**

**AE-C400/EW-C50**

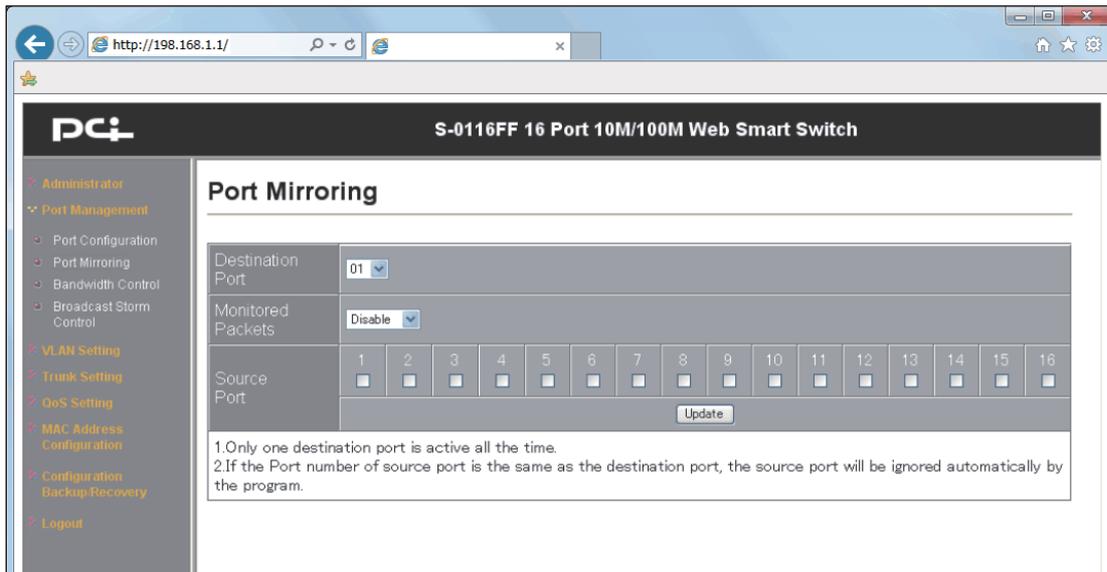
When using a switching hub that features port mirroring, configure the “Port Mirroring” setting. The setting example for Planex communication’s switching hub is shown below.

Configure the “Destination Port” setting for connecting the PC (Wireshark), and the “Source Port” setting for the monitoring target port. Multiple source ports can be selected. If “Tx & Rx” is selected for “Monitored Packets”, both sending and receiving packets can be captured.
