Air Conditioning Control System

Service Handbook

BM ADAPTER

BACS-AP50

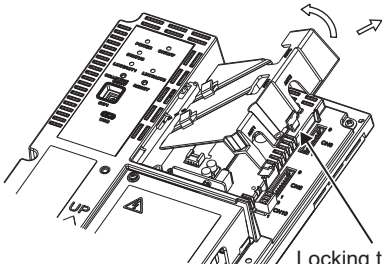
Step		
4	<p>Lift and remove the expansion slot cover while pushing the locking tab.</p> <ul style="list-style-type: none"> If the communication antenna is protruding from inside the cover, be careful not to apply any force or impact to the antenna. If no communication antenna is installed, go to step 7.

<p>Locking tab</p>
5	<p>Remove the mounting screws B (two screws) from the board (communication module) to which the communication antenna is connected.</p>

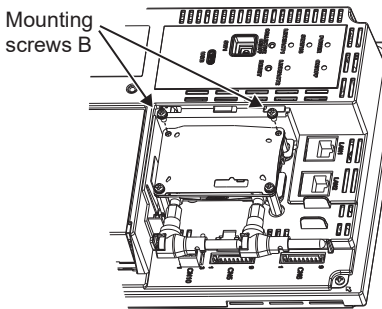
<p>Mounting screws B</p>
6	<p>(Perform the step below if a cellular communication board is mounted.) Turn the cellular communication board over as shown in the figure, remove the mounting screws C (two screws) from the internal board, and lift and remove the internal board. Go to step 8.</p>

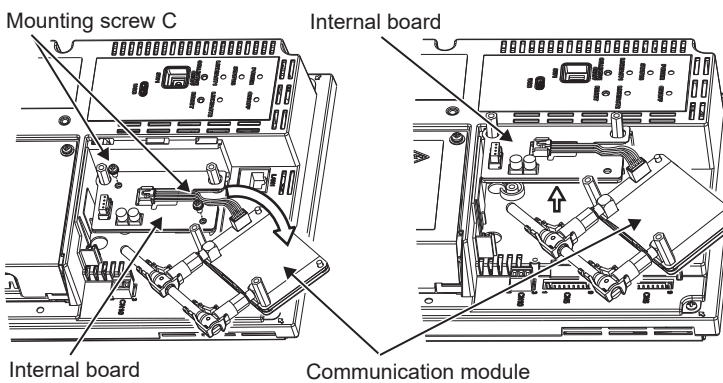
<p>Mounting screw C</p> <p>Internal board</p> <p>Internal board</p> <p>Communication module</p>
7	<p>Remove the mounting screws C (two screws) from the internal board, and lift and remove the internal board.</p>

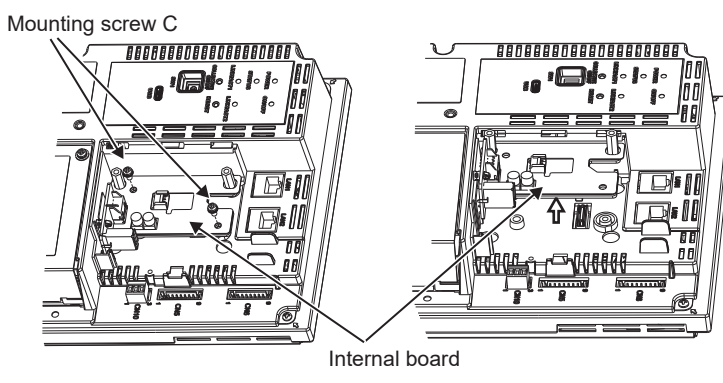
<p>Mounting screw C</p> <p>Internal board</p>

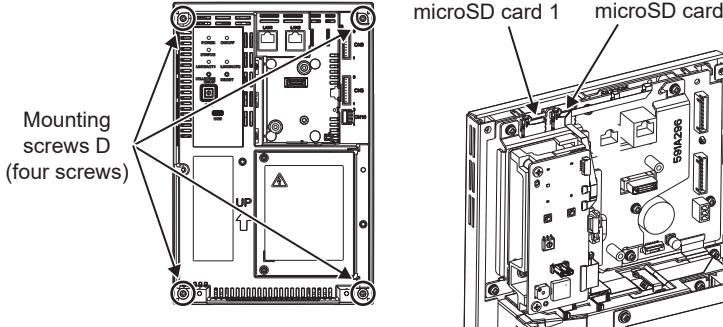
8	<p>Remove the mounting screws D (four screws) from the front panel, and remove the black cover. The SD card slots on the side of the controller will be visible.</p>

<p>Mounting screws D (four screws)</p> <p>microSD card 1</p> <p>microSD card 2</p>

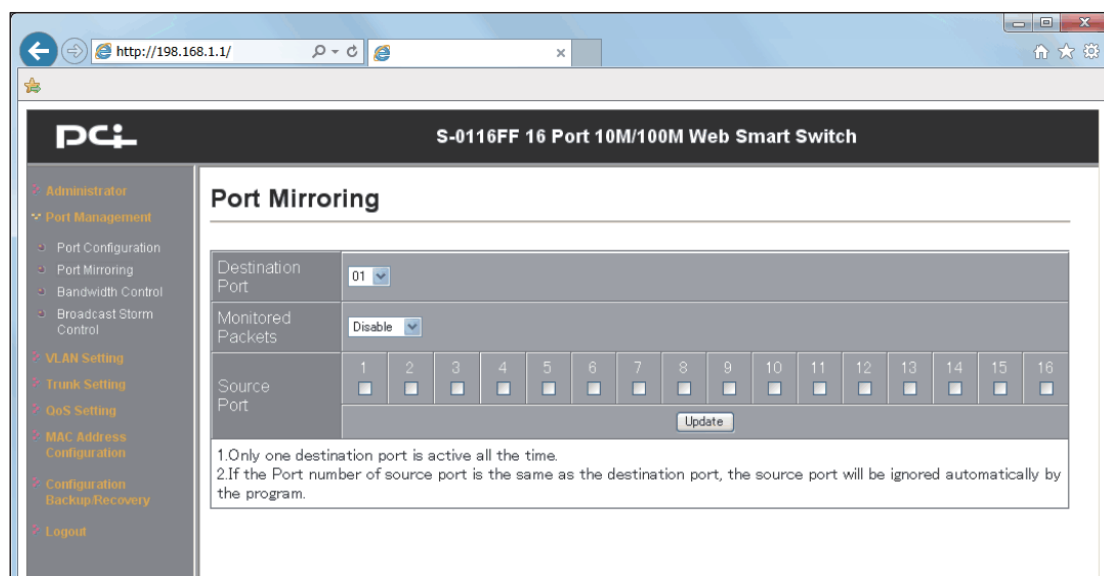
When using a switching hub that features port mirroring, configure the “Port Mirroring” setting. The setting example for Planex communication’s switching hub is shown below.

Configure the “Destination Port” setting for connecting the PC (Wireshark), and the “Source Port” setting for the monitoring target port. Multiple source ports can be selected.

If “Tx & Rx” is selected for “Monitored Packets”, both sending and receiving packets can be captured.
