Air Conditioning Control System

# Service Handbook

## BM ADAPTER

**BACS-AP50**

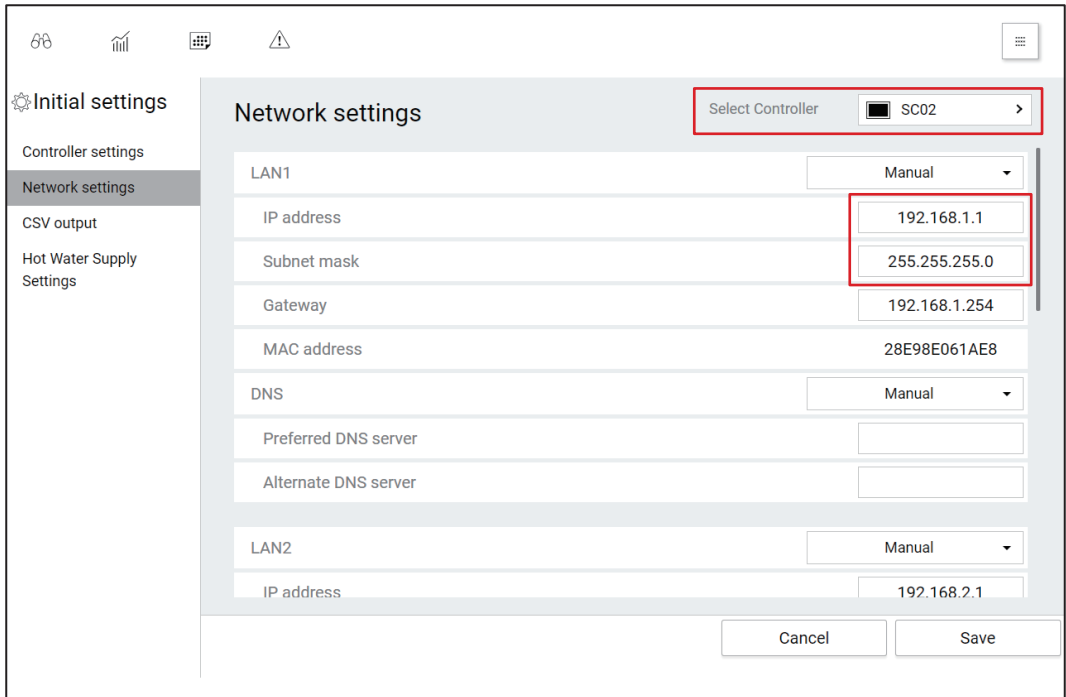
(2) How to check the IP address of the EW-C on the LCD screen of the AE-C

Select [Initial settings] - [Network setting] screen, and then select the AE-C/EW-C connected to the LAN in the Select Controller box to check the IP address.

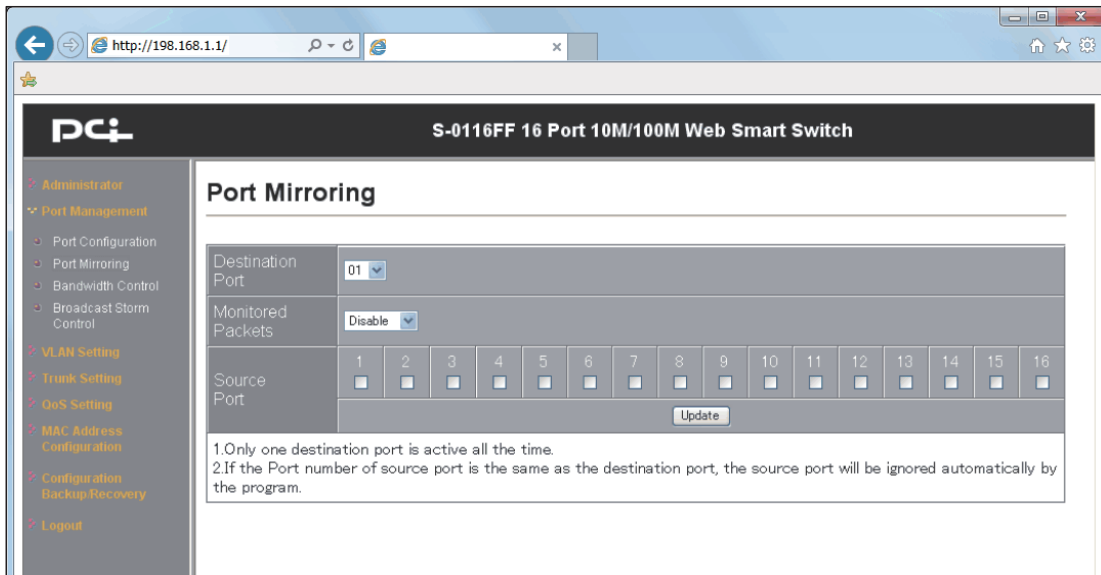
When using a switching hub that features port mirroring, configure the “Port Mirroring” setting. The setting example for Planex communication’s switching hub is shown below.

Configure the “Destination Port” setting for connecting the PC (Wireshark), and the “Source Port” setting for the monitoring target port. Multiple source ports can be selected.

If “Tx & Rx” is selected for “Monitored Packets”, both sending and receiving packets can be captured.

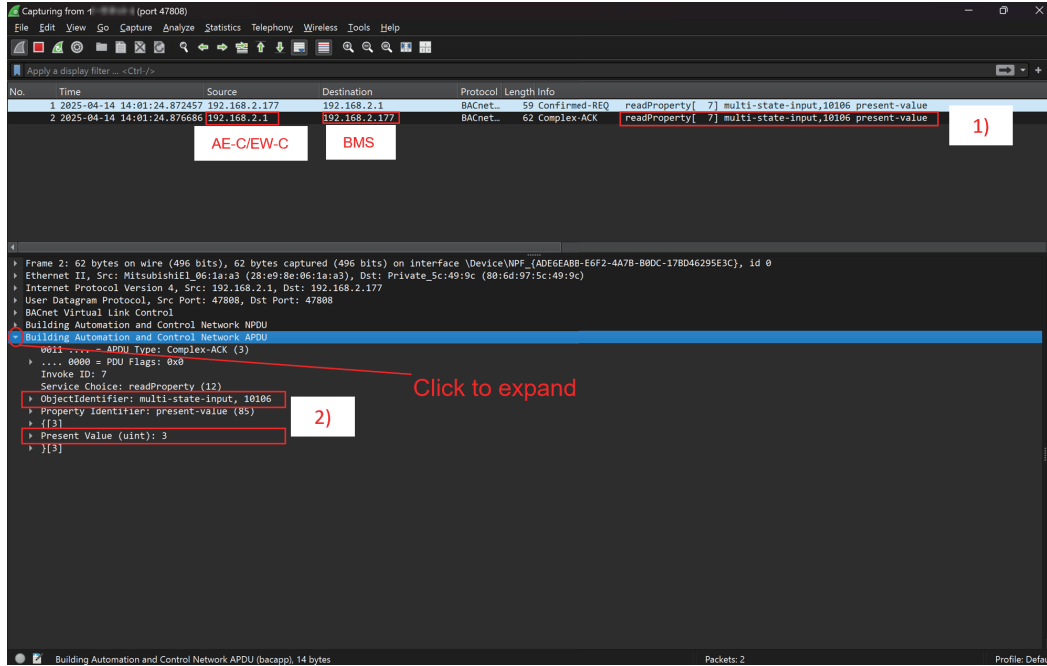
Example (1): When the “Operational Mode State” object is read out by the “ReadProperty” service

- 1) Confirm the response from AE-C/EW-C (192.168.2.1) to BMS (192.168.2.177).
- 2) Operation mode state (01xx06) of Group No.1:  
 Present value is 3 (= Fan).  
 (For the BACnet objects supported by AE-C/EW-C and the meanings of their instance numbers and present values, refer to section “Instance number for basic functions” in the AE-C/EW-C/BACS-AP50 Instruction Book (BACnet function).)
