# SERVICE PARTS LIST FOR MITSUBISHI ELECTRIC PACKAGED AIR-CONDITIONERS

Series : CMB

Oct. 2025  
BWE025340

INDEX
CMB-M104NU-MA-SV
CMB-M106NU-MA-SV
CMB-M108NU-MA-SV
CMB-M1012NU-MA-SV
CMB-M104NU-MB-SV
CMB-M108NU-MB-SV

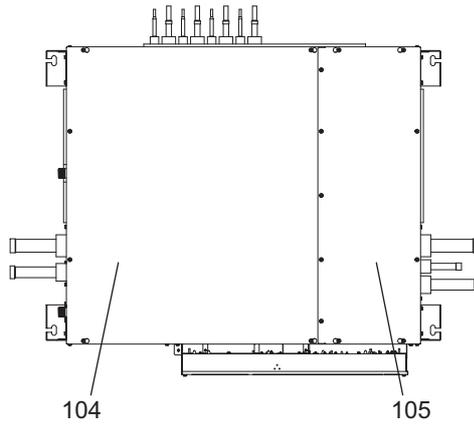
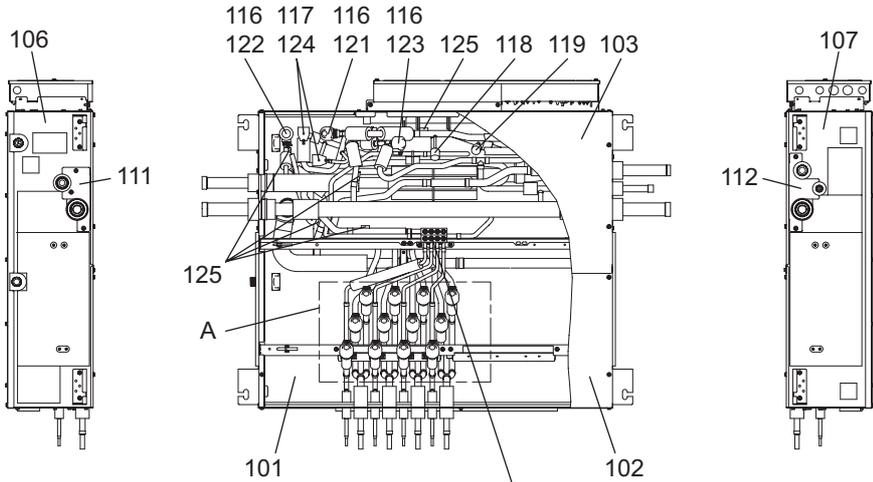
\* Check valve do not set service parts.  
Because, the quality securing of them  
when exchanging parts is difficult.

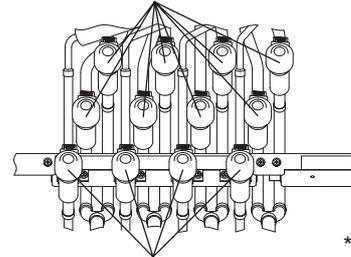
A

113 . 115 . 120

\* Part No. 115 (Linear expansion valve) is  
difficult to be replaced individually because  
it is close to the peripheral parts.  
It is recommended to replace No. 113 or  
114 (Pipe assy LEV), which includes Part No. 115.

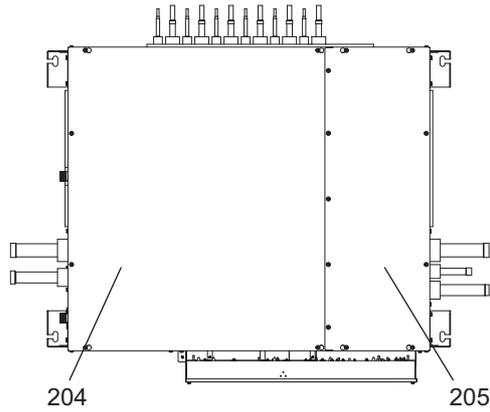
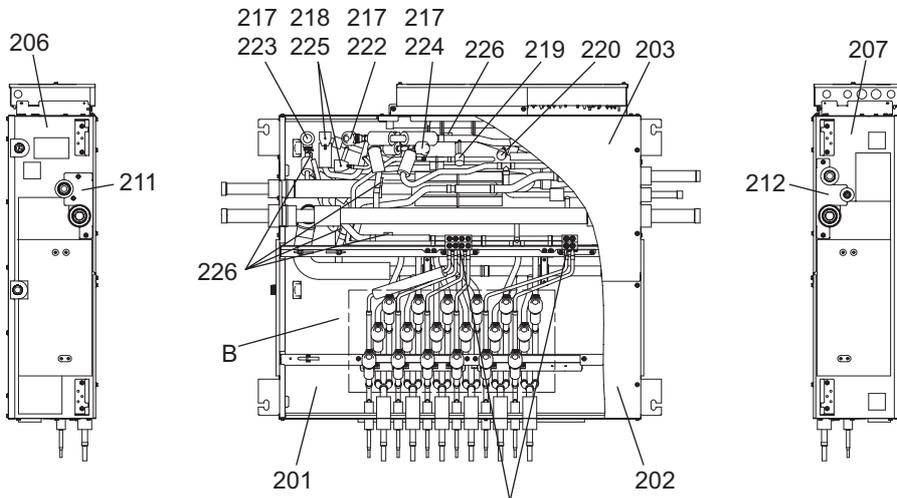
\* Check valve do not set service parts.  
Because, the quality securing of them  
when exchanging parts is difficult.

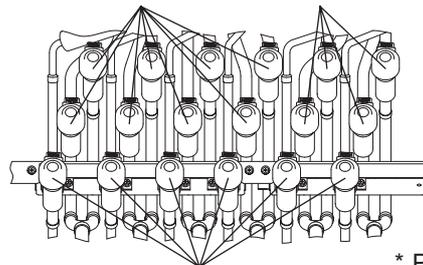
B

213 . 216 . 221      214 . 216 . 221

215 . 216 . 221

\* Part No. 216 (Linear expansion valve) is  
difficult to be replaced individually because  
it is close to the peripheral parts.  
It is recommended to replace No. 213 or  
214 or 215 (Pipe assy LEV), which includes  
Part No. 216.

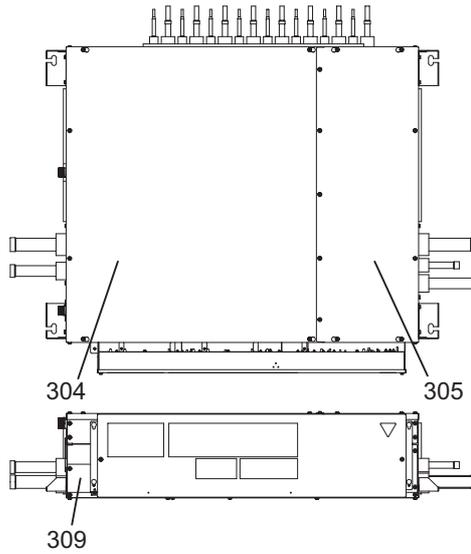
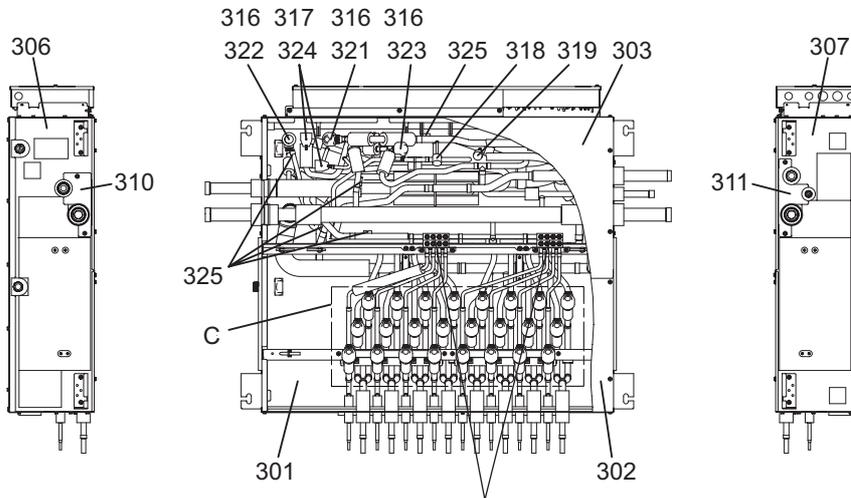
\* Check valve do not set service parts.  
Because, the quality securing of them  
when exchanging parts is difficult.

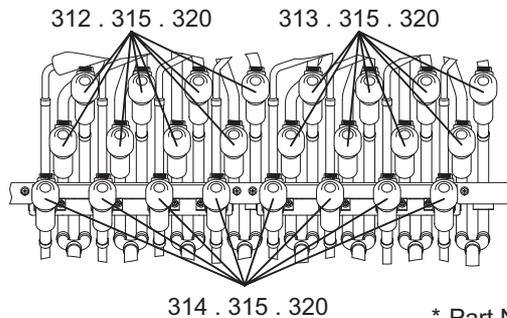
C

314 . 315 . 320

\* Part No. 315 (Linear expansion valve) is difficult to be replaced individually because it is close to the peripheral parts. It is recommended to replace No. 312 or 313 or 314 (Pipe assy LEV), which includes Part No. 315.

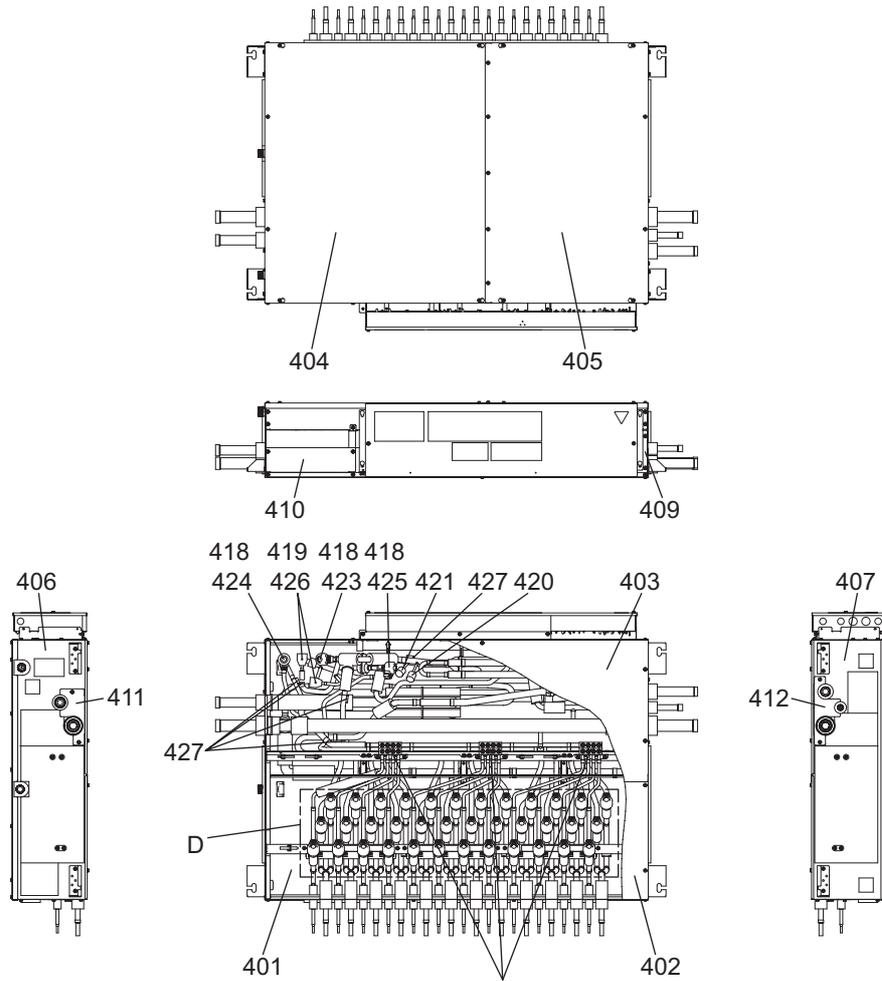
\* Check valve do not set service parts.  
Because, the quality securing of them  
when exchanging parts is difficult.

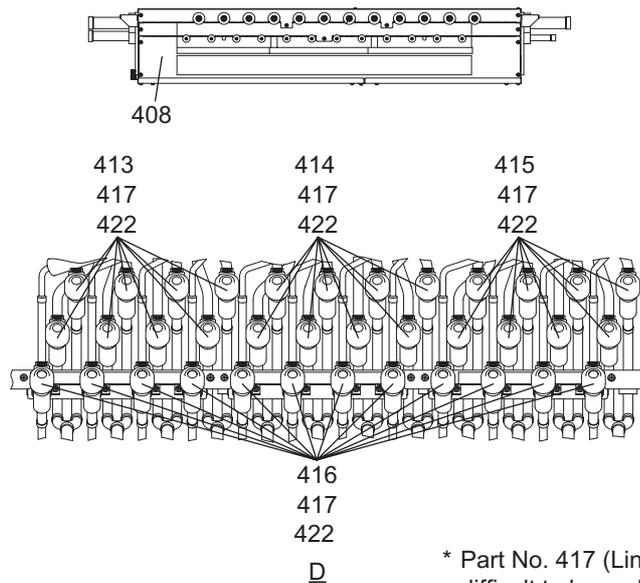
\* Part No. 417 (Linear expansion valve) is  
difficult to be replaced individually because  
it is close to the peripheral parts.  
It is recommended to replace No. 413, 414,  
415 or 416 (Pipe assy LEV), which includes  
Part No. 417.

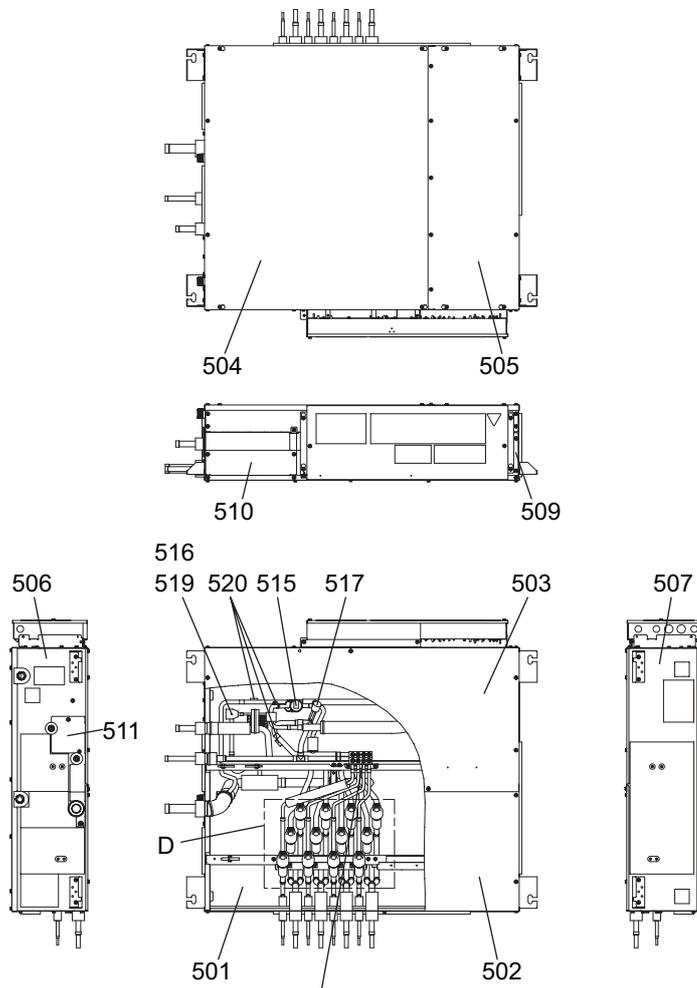
\* Check valve do not set service parts.  
Because, the quality securing of them  
when exchanging parts is difficult.

513  
514  
518  
E

\* Part No. 514 (Linear expansion valve) is  
difficult to be replaced individually because  
it is close to the peripheral parts.  
It is recommended to replace No. 512 or 513  
(Pipe assy LEV), which includes Part No. 514.

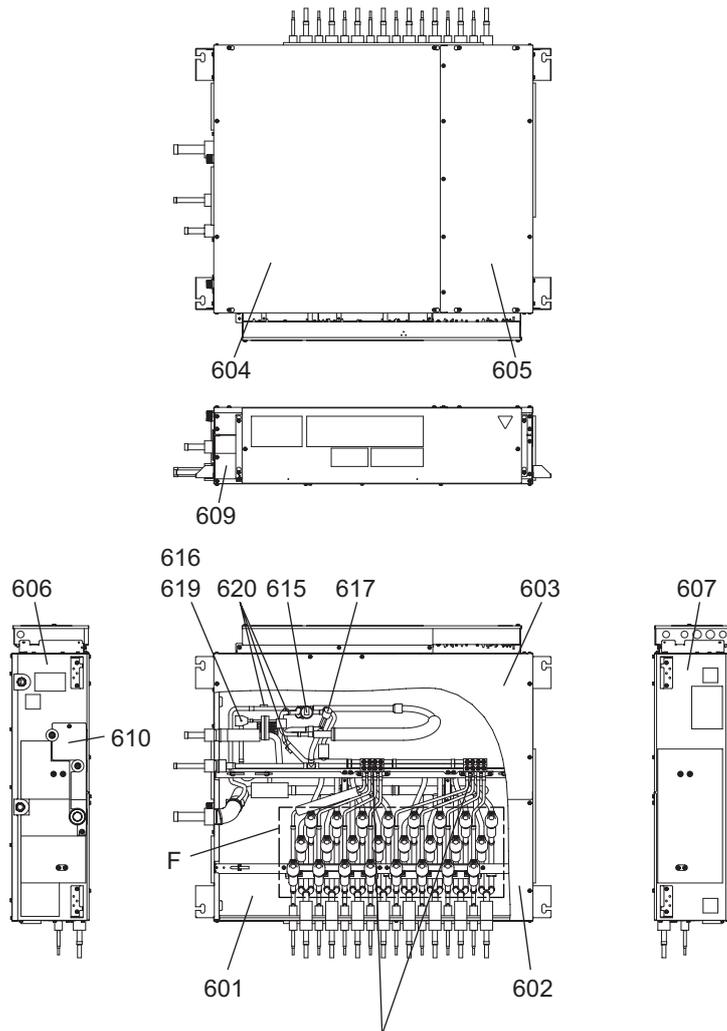
\* Check valve do not set service parts.  
Because, the quality securing of them  
when exchanging parts is difficult.

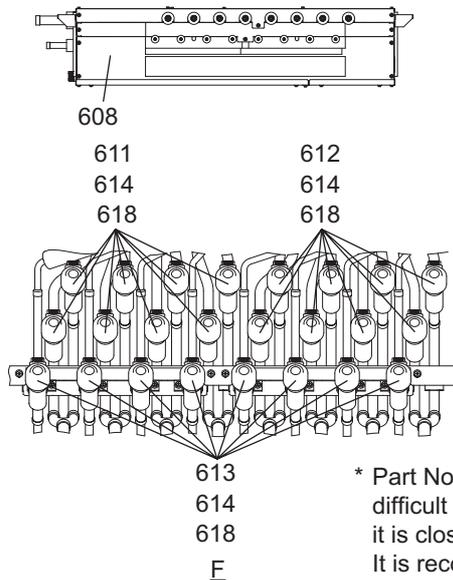
\* Part No. 614 (Linear expansion valve) is  
difficult to be replaced individually because  
it is close to the peripheral parts.  
It is recommended to replace No. 611 or 612 or  
613 (Pipe assy LEV), which includes Part No. 614.
